# Manhole Inspection Summary

Manhole # S13SS1016MH

Insp Date: **11/9/06 9:27 AM**

**Location** Address: **5123 SUNSET RD**

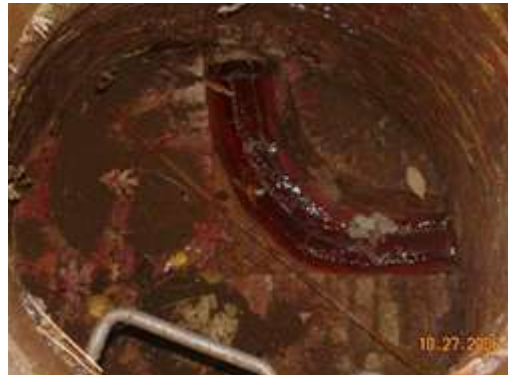
Top View

Frame leaks. Adjustment root intrusion and infiltration. Bench debris.

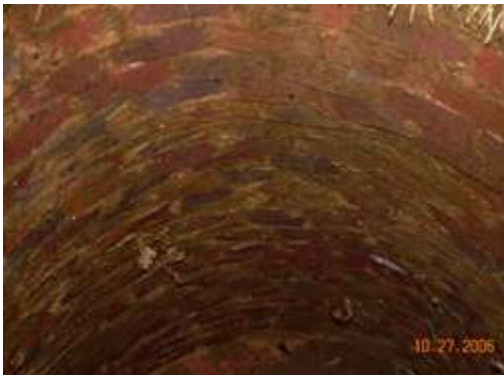
Defect

Adjustment, Corbel, and Barrel infiltration.

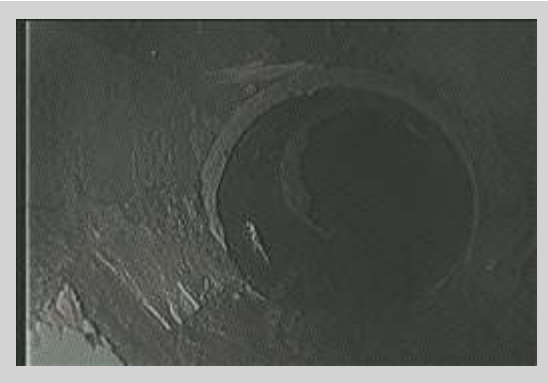
### 8 in. Circular Gravity Sewer Pipe Out @ 12 O'Clock

Infiltration: **None** Pipe Seal Cond: **Unknown**

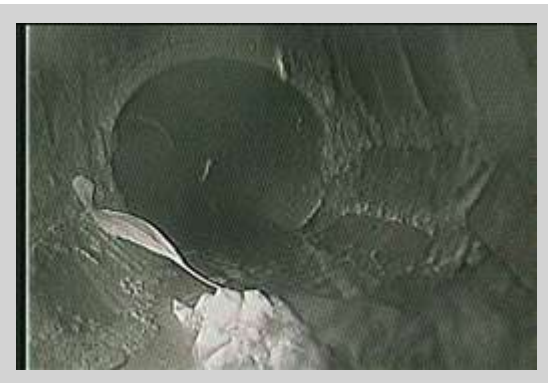
### 8 in. Circular Gravity Sewer Pipe In @ 3 O'Clock

Infiltration: **None** Pipe Seal Cond: **Cracked**
